**The Encroaching Ganga and Social Conflicts: The Case of  
West Bengal, India.**

*Kalyan Rudra*

**Department of Geography,  
Habra S.C. Mahavidyalaya (College), West Bengal, India.**

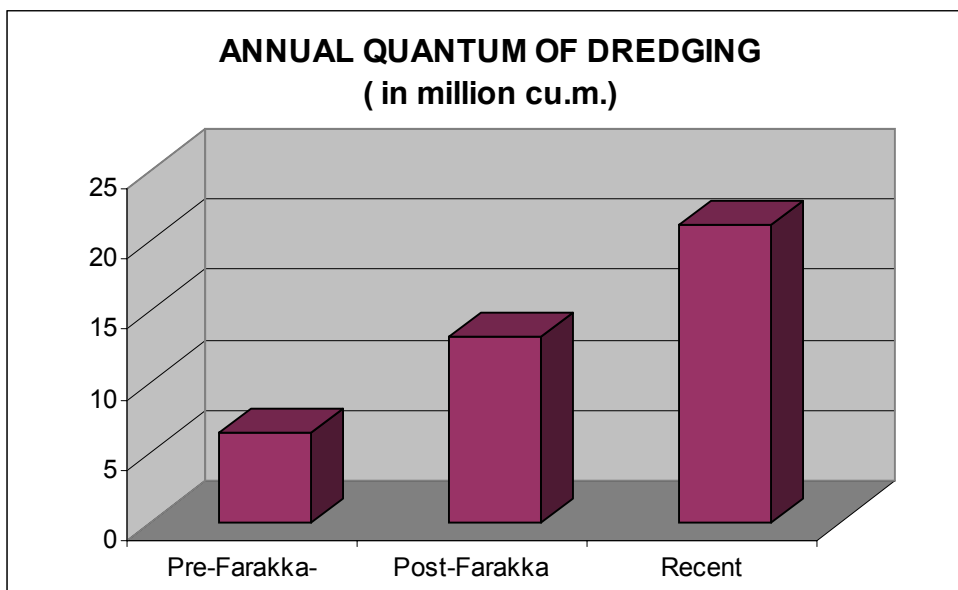
**Fig.2: Pre-Farakka- till 1975; Post-Farakka-1976-1994; Recent-1999-2003.**

The induced water through Ganga-Bhagirathi feeder canal was supposed to flush the sediment load from the estuary and keep the navigation channel free from siltation. But the objective was proved a myth as sedimentation in the estuary continues unabated. It is admitted in the published document of the Kolkata Port Trust that induced discharge from Farakka Barrage has had not been able to negate the estuarine sedimentation. The annual quantum of dredging has increased from 6.40m.m<sup>3</sup> during pre-farakka days to 13.24m.m<sup>3</sup> during post-farakka days. (Sanyal and Chakraborty, 1995) This has further been increased to 21.18m.m<sup>3</sup> per annum during 1999-2003.

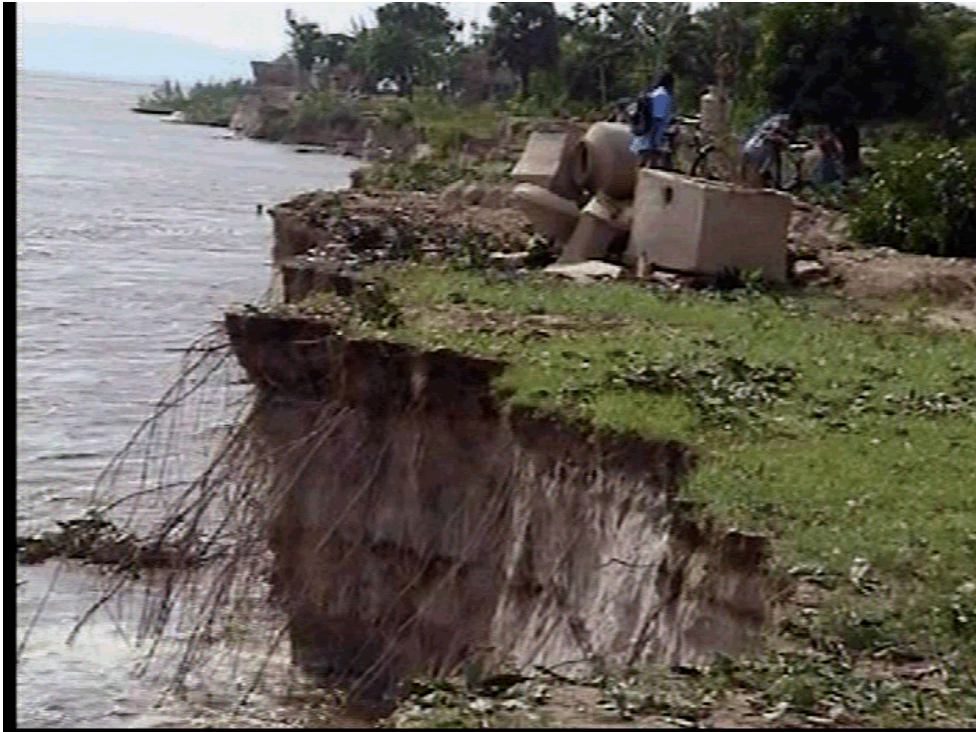
Plate-1: Bank stratigraphy exposed near Panchanandapur, Malda.

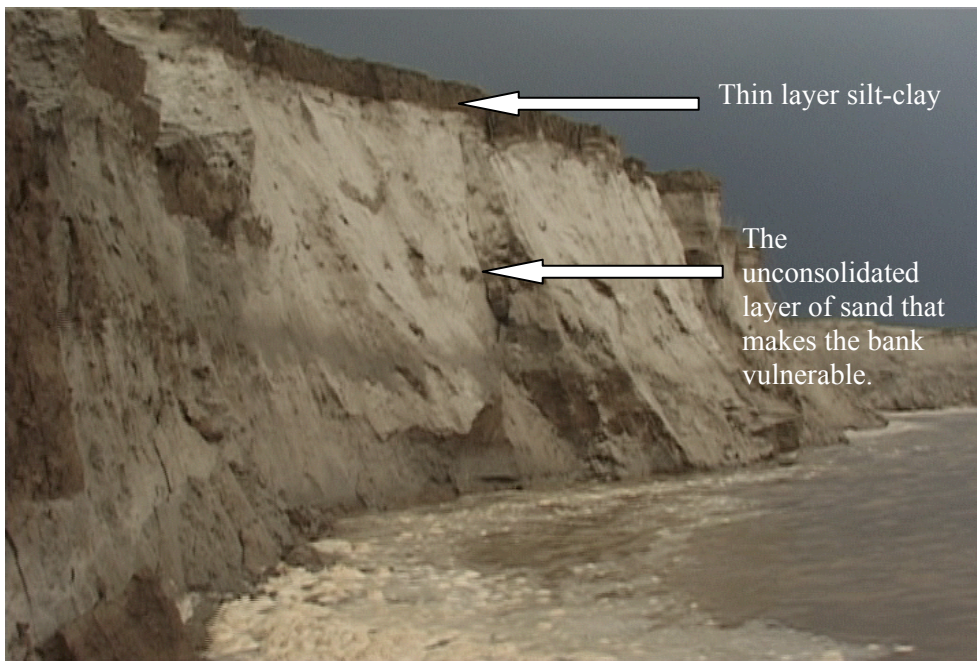
Plate-2: Shelving Bank at Nirmalchar where thin clay-layer overlays unconsolidated micaceous sand-layer.

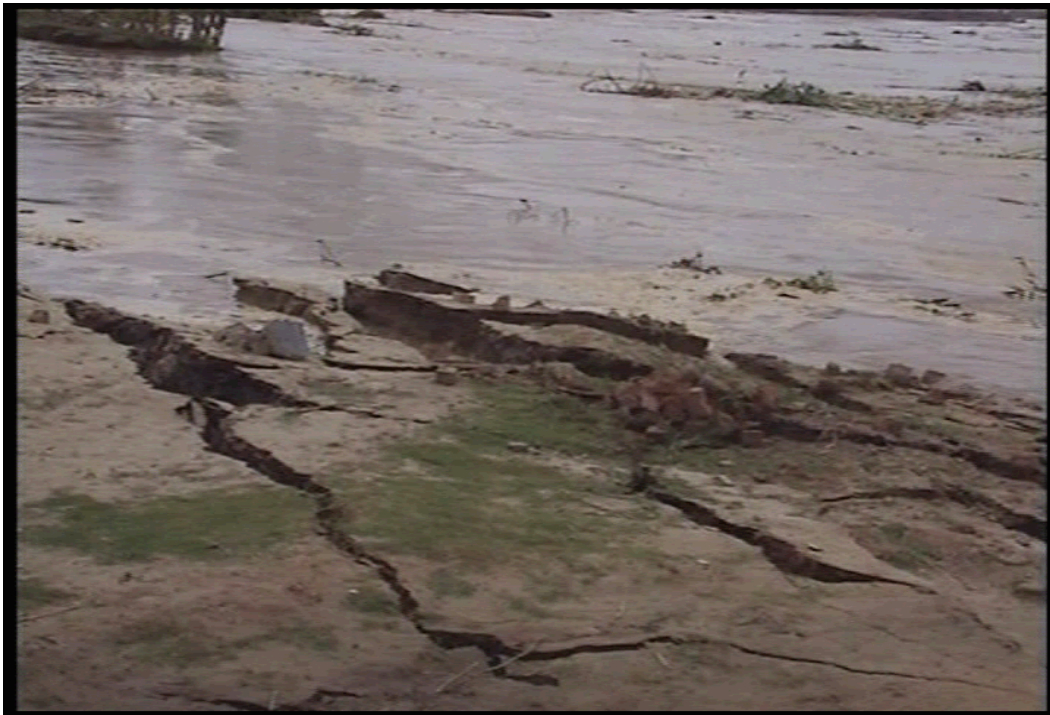
Plate-3: Linear cracks developed along the bank due to undercutting of basal sand-layer.

The erosion along the bank of the Ganga is the phenomenon of the monsoon months (June – September), and it has two distinct phases: the pre-flood and post-flood erosion. The fluctuation of discharge and stratigraphy of the bank are two major factors contributing to the bank erosion. The peak discharge of the river may be to the tune of  $75.90 \times 10^3$  cumec, as was observed in September 1998. The fast moving current during the rising stage of discharge removes unconsolidated sediment from the base of the shelving bank which ultimately collapses. The stratigraphy of the bank, being composed of micaceous sand at the bottom and silt-clay upon it, appears to be responsible for this process. The post-flood erosion is related to the effluent flow of the ground water into the river. This occurs during the falling stage of the discharge. The flow of the ground water toward the river leads to liquefaction and flowage of basal sediments of the bank. However, in both cases a linear crack, often 100 metres in length, develops along the bank and the edge of the bank collapse into the river along this line.

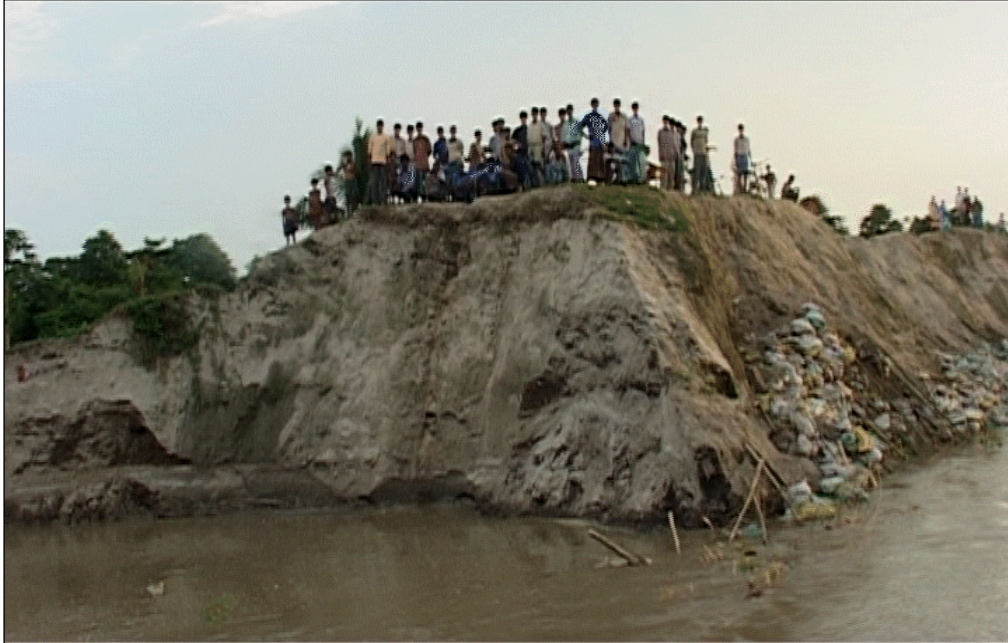
Plate-4: The breached embankment near Panchanandapur. Here the encroaching river threatens to outflank the Farakka Barrage.

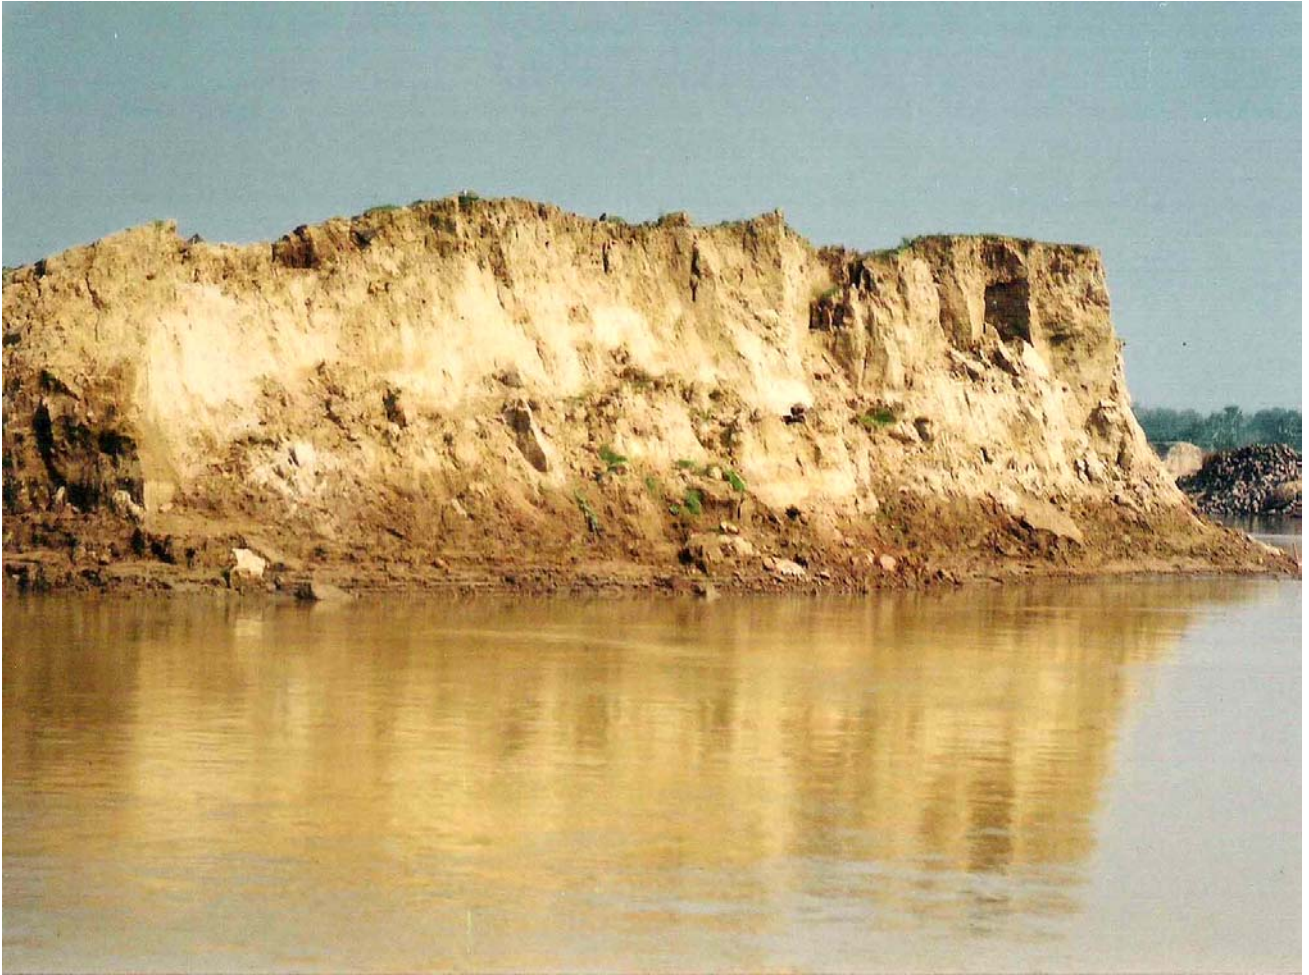
Plate-6: The relic of Embankment no.8 stands on the river (September,2004).

The gnawing river has so far breached eight embankments. The official records regarding the land erosion in Malda is available since 1931. It was observed that 14335 hectares of fertile land was eroded from the left bank of the river from 1931 to 1978 and the total eroded land during the period 1979 to 2004 was measured to be 4247 hectares. More than 200 sq.km. of fertile land was swept away till 2004 and almost equal extent of *char* has emerged along the opposite bank (Maitra,2004)

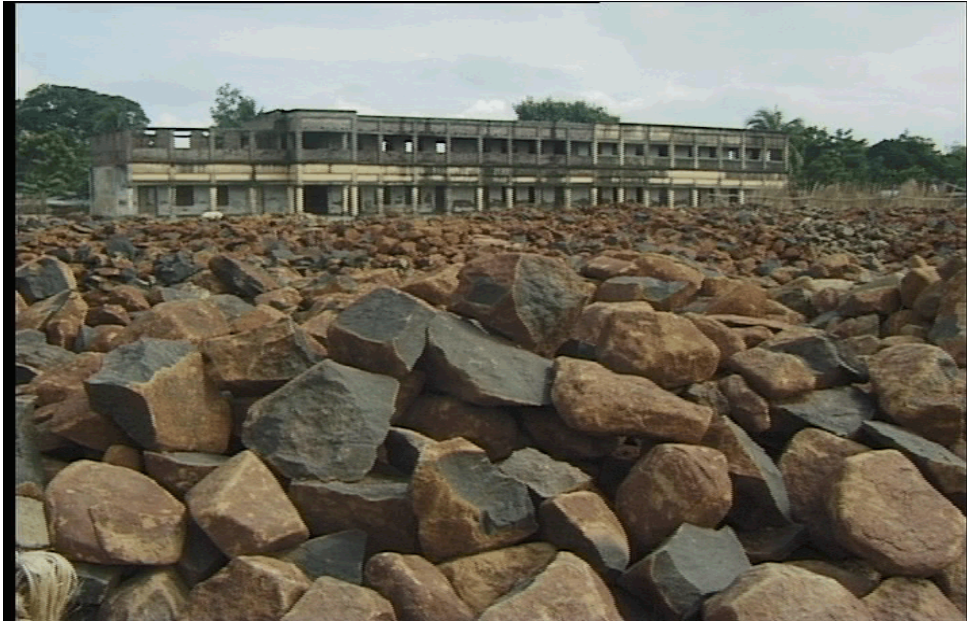
Plate-7: Akheriganj(2000)- the boulders did not ensure protection against erosion.

The bank protection work is so expensive that it often involves Rs. 100000 to protect one metre stretch but it offers no guarantee against erosion. The Government spent sixty million rupees to protect two kilometers long river bank at Akheriganj in 1991 but the newly constructed embankment was washed away in the very next rainy season. Yet bank protection is a popular demand. In some stretches bank restoration and monitoring are important. In Fazilpur, where the encroaching Padma threatens to unite with the Bhagirathi and may jeopardise the main purpose of the Farakka Barrage Project, the preventive measure is of real necessity. But in many areas bank protection works proved futile.

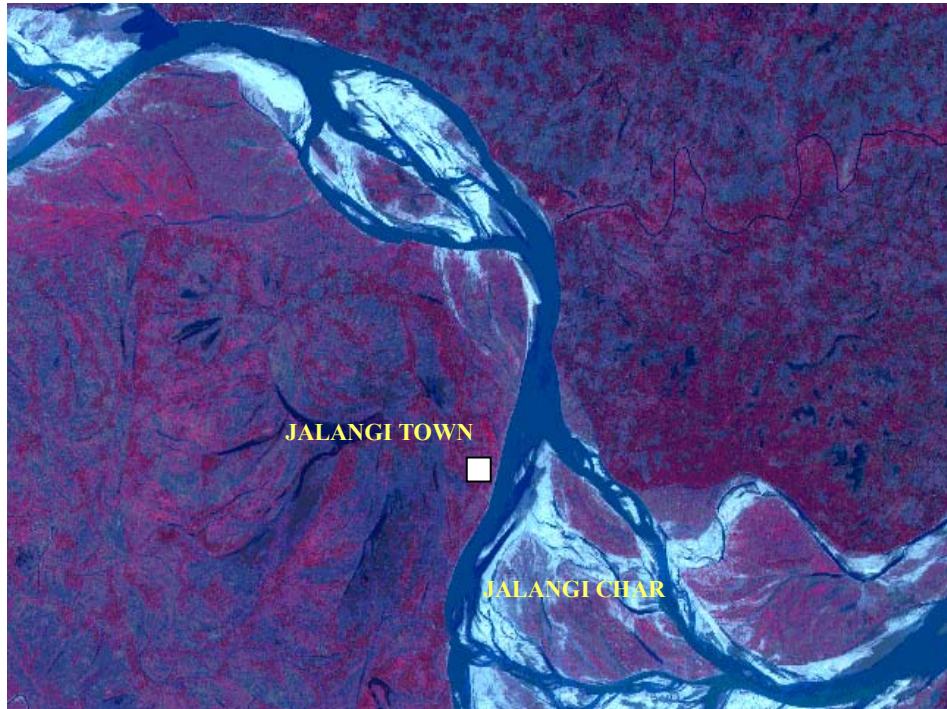
Image-4: The Course of river at Jalangi of Murshidabad.

As the intensity of erosion subsided at Akheriganj, the Padma, attacked human settlements at Jalangi in September 1994 with immense power. In 1990 when this author first visited Jalangi, there was an extensive *Charland* in front of the town and the river was about a kilometre away from the market area. Subsequently, the mighty river changed its course southwards and engulfed high school, police station, panchayet office, market area and as many as 450 houses were submerged (The Statesman, 1994). Even the Behrampur-Karimpur road was delinked and at least 12,000 people became homeless (GoWB Report, 1995). The erosion is nothing new at Jalangi. Rennel (1788) in his ‘Memoir of a Map of Hindustan’ noted : *“During eleven years of my residence in Bengal, the outlet or head of the Jalangi river was gradually removed three quarters of a mile further down and by two surveys of a part of adjacent bank of the Ganges, taken about the distance of nine years from each other, it appeared that the breadth of an English mile and a half has been taken away.”*
